**SAS Superstructure**

Location: 04-SF-80-13.2 / 13.9

Daily Diary Report by Bid Item

Contract No.: 04-0120F4

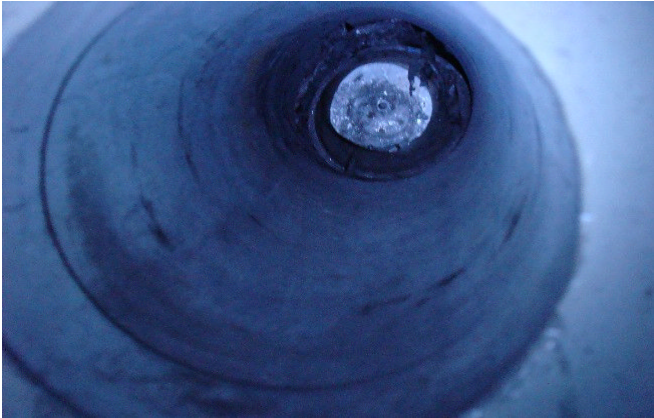
Aluminum mandrel lodged/wedged in the W2 cap beam for continuity tendon E41B

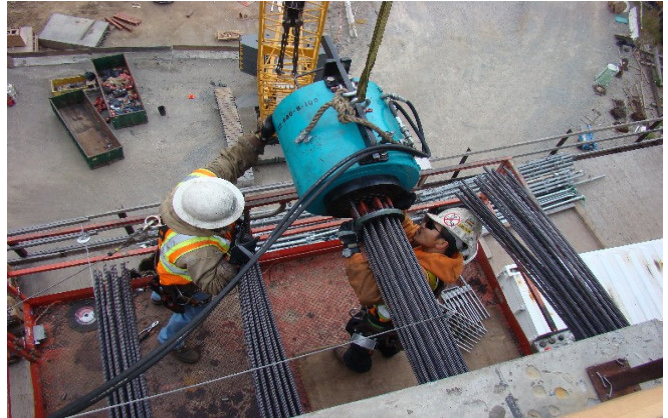
Positioning the multistrand ram to stress continuity tendon E2B.

- Stressed continuity tendons E1B to E5B, E39B, E40B, and E42B using the multistrand ram CH600-8-109 and with gauge A. ABF assisted SDI using the Liebherr crane positioning the multistrand ram.
- Continued to cut live and dead end strand tails of continuity tendons already stressed and placed grout caps and tubes at the live and dead ends of these tendons. It should be noted that the dead end strand tails were cut with the saw today for the "B" continuity tendons since it wasn't an issue getting the band saw in between some of the stiffener plates inside OBG lift 1E.
- Continued to use the grout pump on top of the W2 cap beam to test the air pressure in the continuity tendon ducts. ABF began to seal leaks with silicone at the OBG bearing plate to stiffener plate joint.
